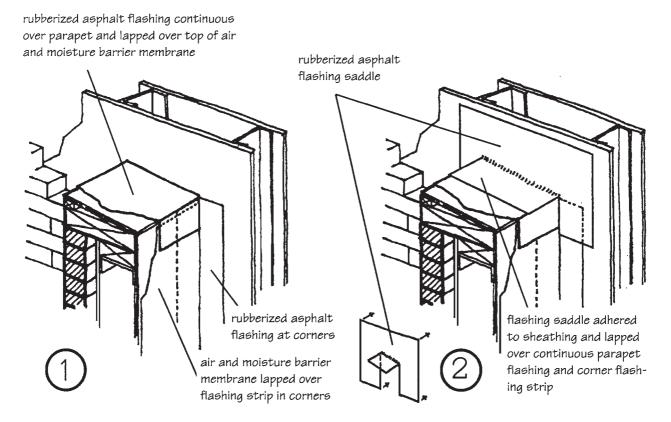
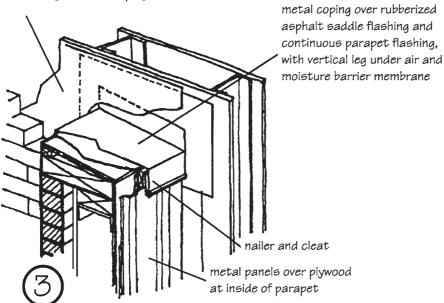
air and moisture barrier membrane lapped over rubberized asphalt saddle flashing and vertical leg of metal coping

Figure 10-59 Flashing at parapet-to-wall intersection.

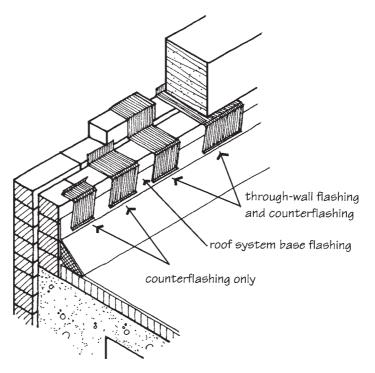
Figure 10-60 Counterflashing and through-wall flashing/counter flashing combinations.
